# Manhole Inspection Summary

Manhole # S25UU1018MH

**Location** Address: **7 INDIAN LN**

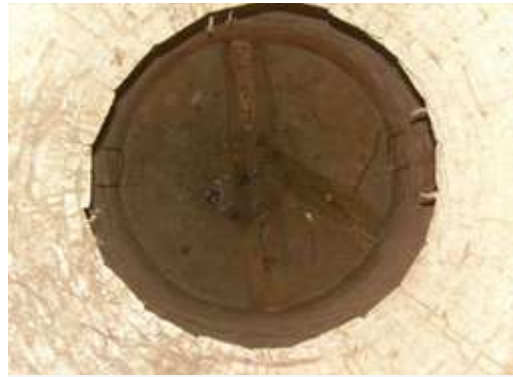
Top View

Corroded and missing steps. Evidence of surcharge - Bench debris. Channel debris.

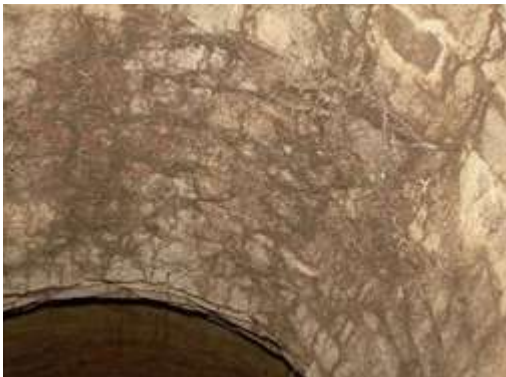
Defect

Corbel root intrusion and infiltration.

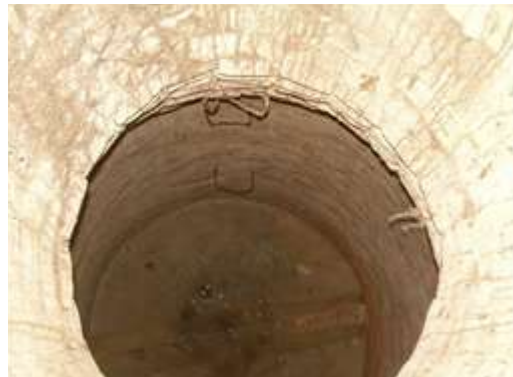
Defect

Adjustment, Corbel and Barrel infiltration.

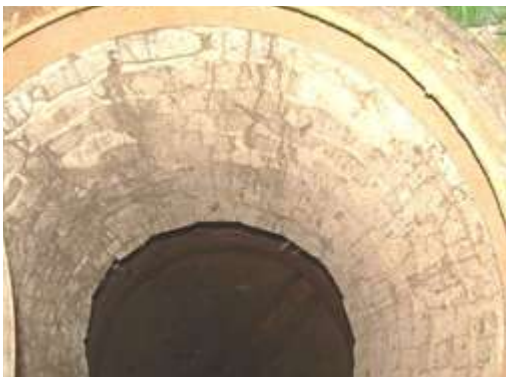
Defect

Frame leaks. Adjustment deterioration and infiltration. Corbel infiltration.

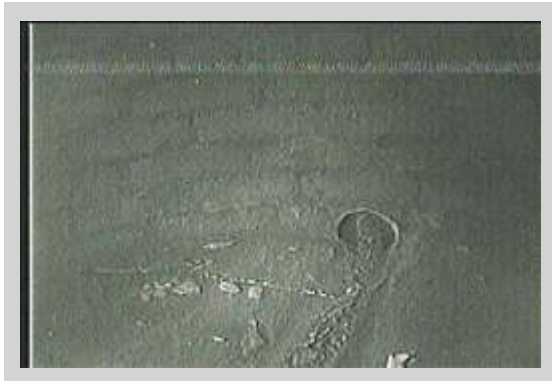
### 4 in. Circular Gravity Sewer Pipe In @ 4 O'Clock

Barrel deterioration and infiltration.

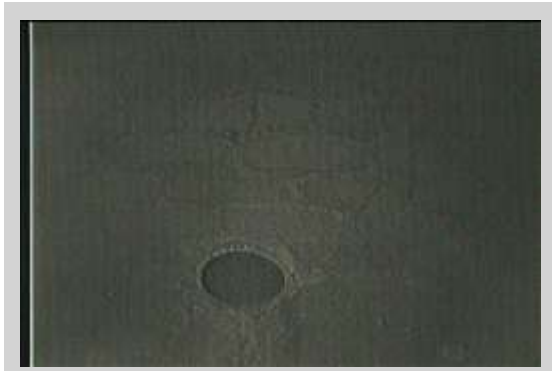
Pipe In @ 6 O'Clock

Barrel deterioration and infiltration.
